TRAACA Tech Day: Compression Test
By Craig Brown

July 13, 2013 at Bill O'Rourke's Garage

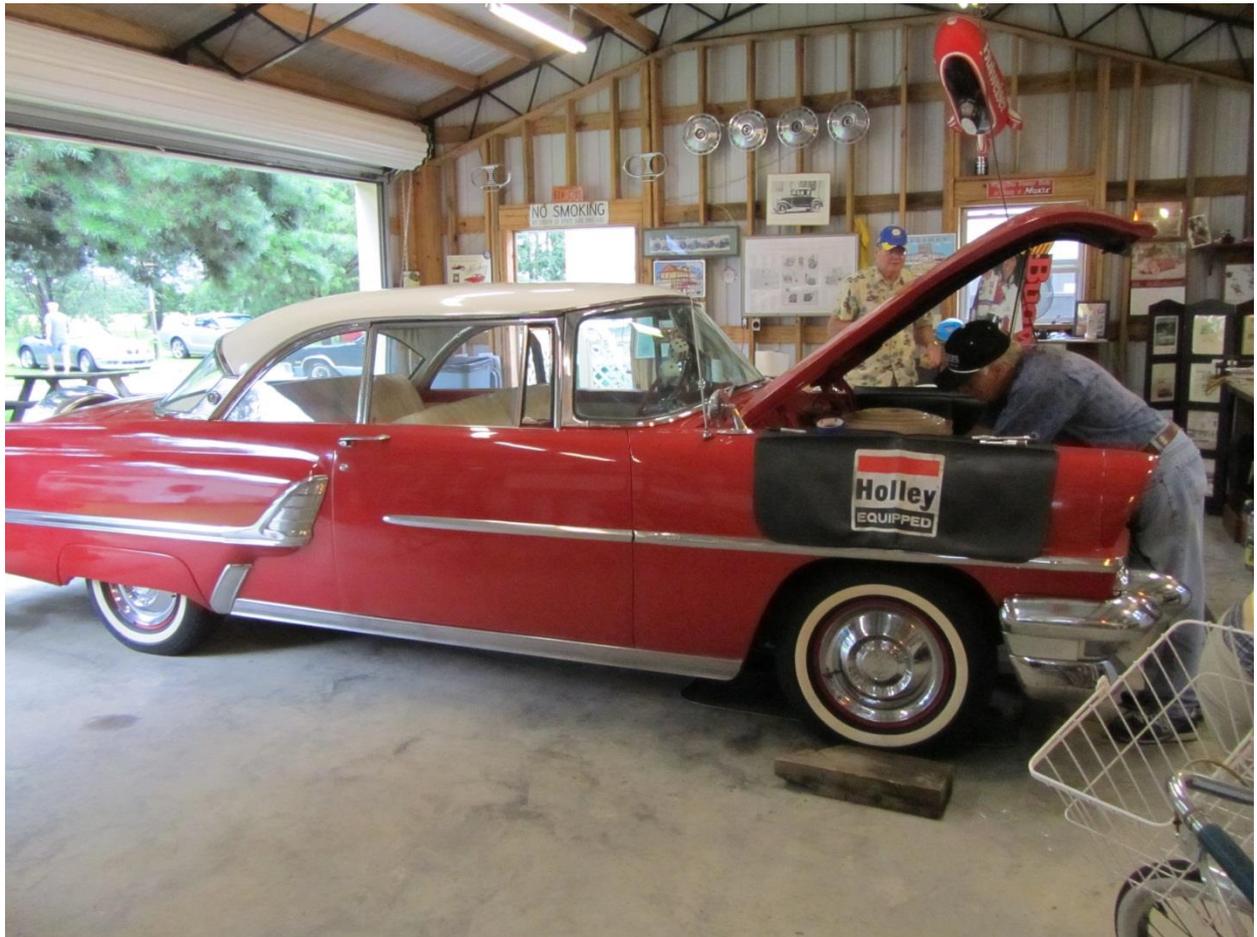
Bill B. was experiencing an intermittent shake and stumble at idle in his excellent 1955 Mercury Monterey and this seemed like a perfect excuse for a "Tech Day."

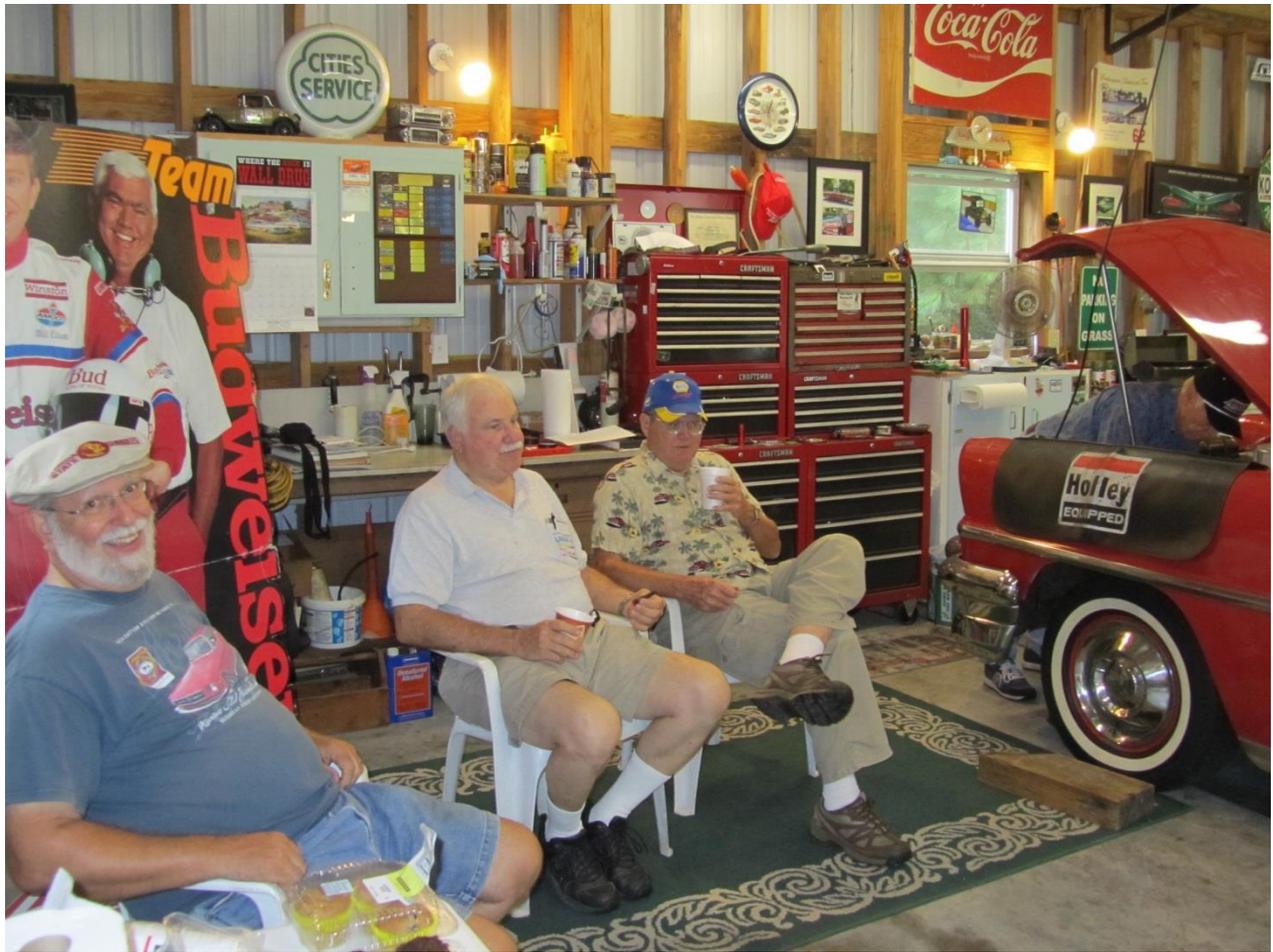
By 0900 Bill O'Rourke's garage was open and Bill B. was extracting spark plugs to do a compression test. The original theory was the stumble could be caused by a sticking valve or improper valve clearance. A compression test would quickly show if a valve was sticking open and a read of the spark plugs could yield additional clues.

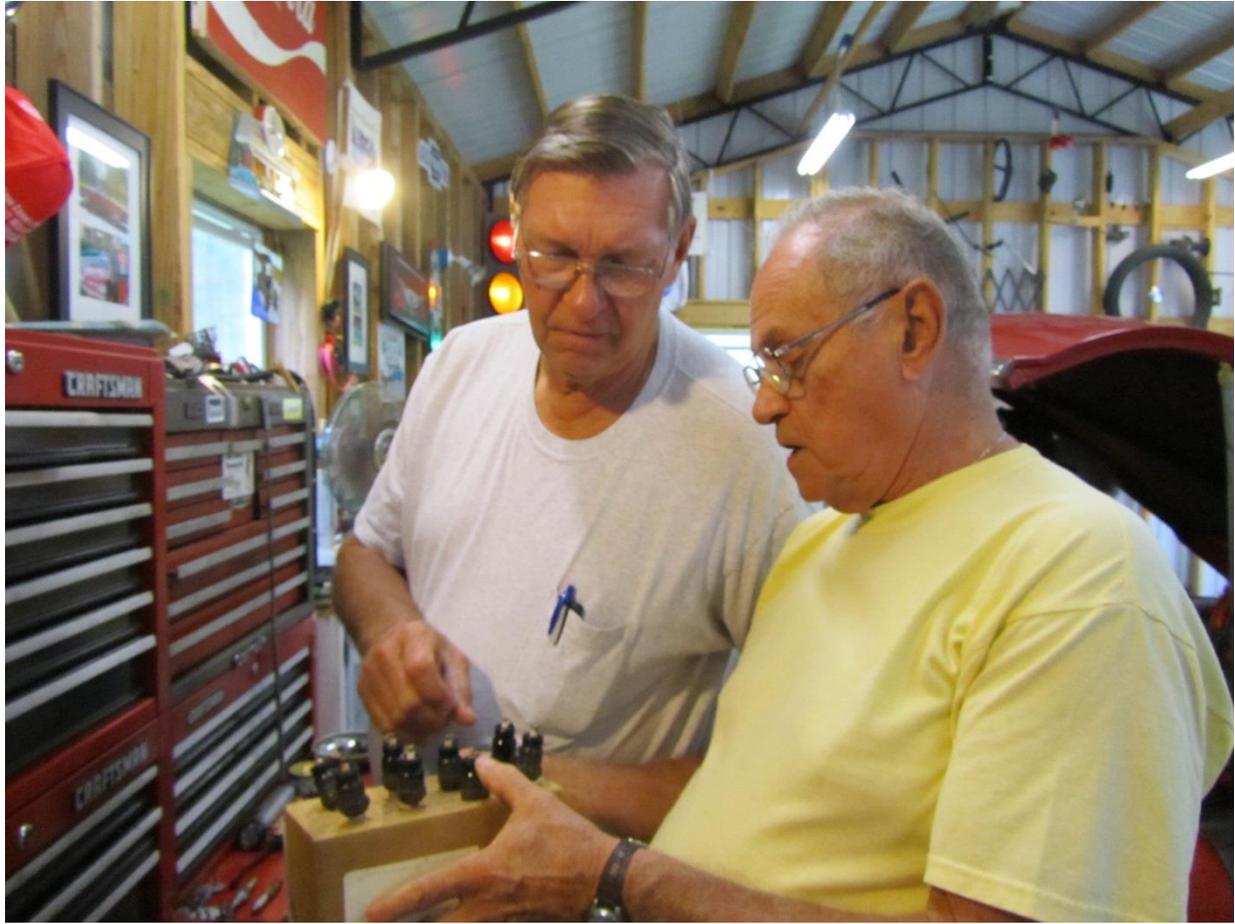
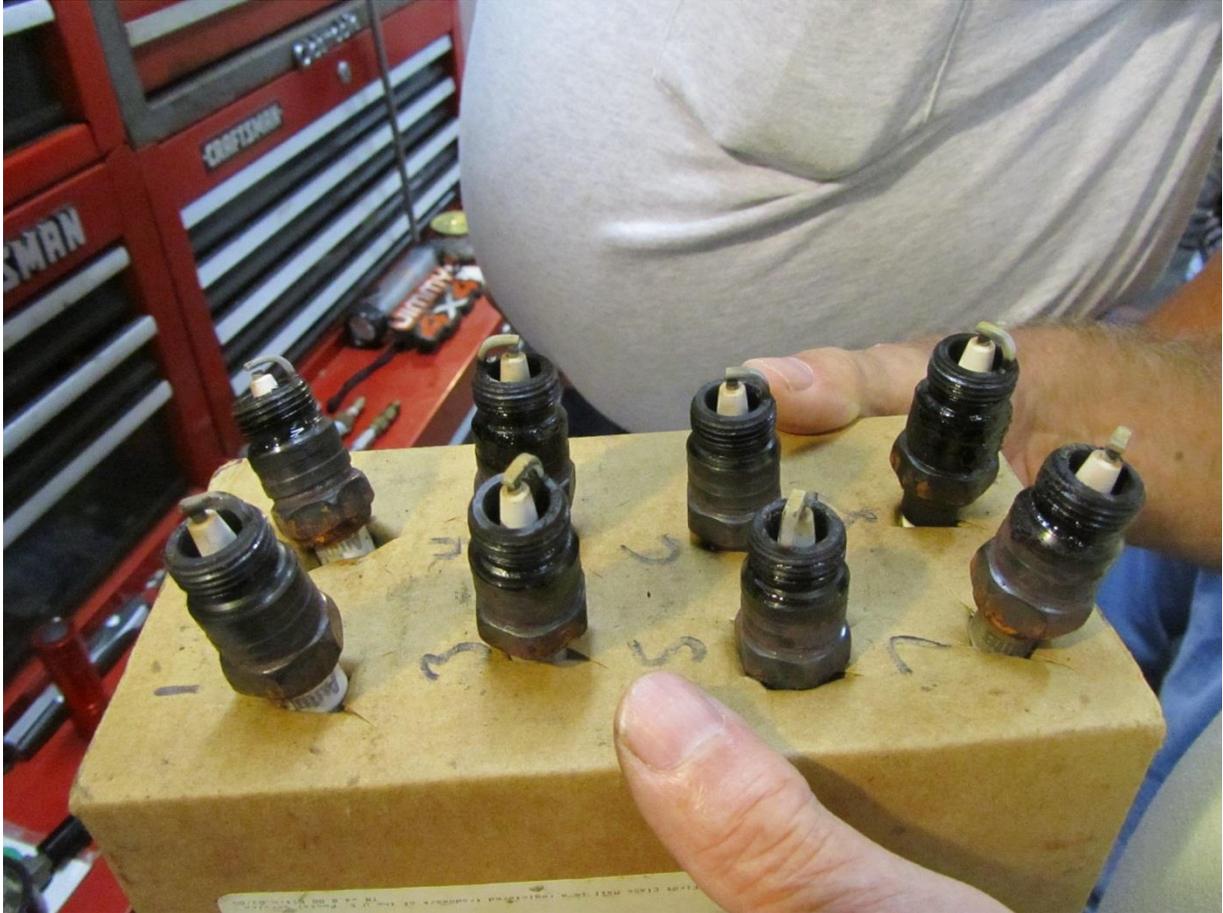
Soon the spark plugs were all removed and mounted in the carefully crafted holder (an old box with holes punched in it). The plugs had been in service for about two years and the insulator tips were all still bright white with little color variation between them. The consensus was this indicated a lean condition because the tips were not light tan. There was no sign of fouling or that one plug was consistently not firing.

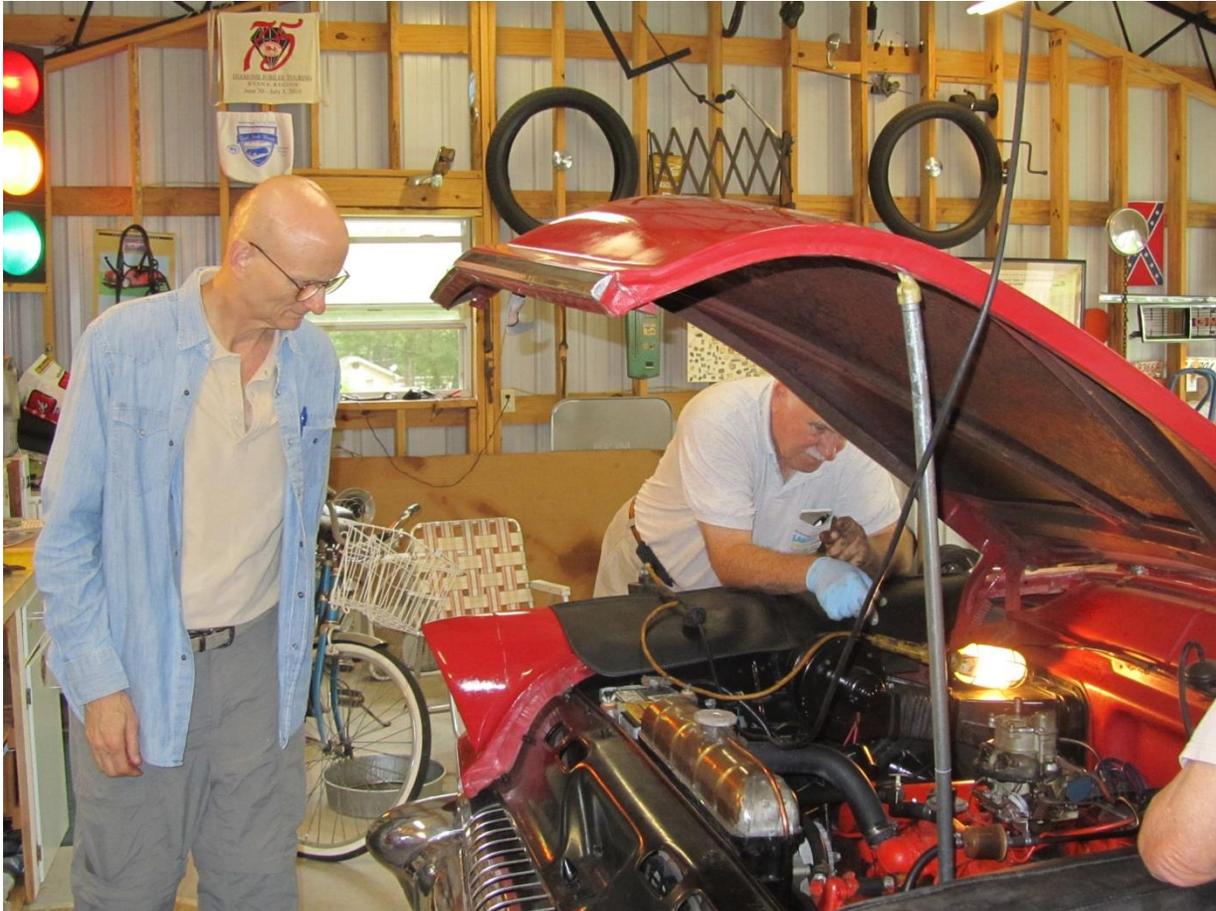
A variety of compression gauges were offered for the test. A push-in gauge purchased for \$3.00 from the TRAACA Chili Cook Off & Auction was first up. A poor seal and leaking Schrader valve proved it was not up to the job. A second push-in gauge was tried, but poor sealing caused it to be set aside. A new screw-in gauge was pressed into service and yielded 142 psi on the first cylinder tested. The specification is 130 psi for this engine, so speculation about possible hot-rodding not externally visible began. Removing the gauge from the first cylinder left the adapter tip in the spark plug hole. After removing the tip, it was secured onto the gauge hose with a wrench to ensure it would stay put.

The compression test yielded 140-142 psi on all cylinders with the exception of #6 and #7. These two cylinders were right at the specified 130 psi, so compression was not a problem.
