## TRAACA Tech Day: Front Axle Bearing Replacement By Craig Brown

March 9, 2013 at Bill O'Rourke's Garage

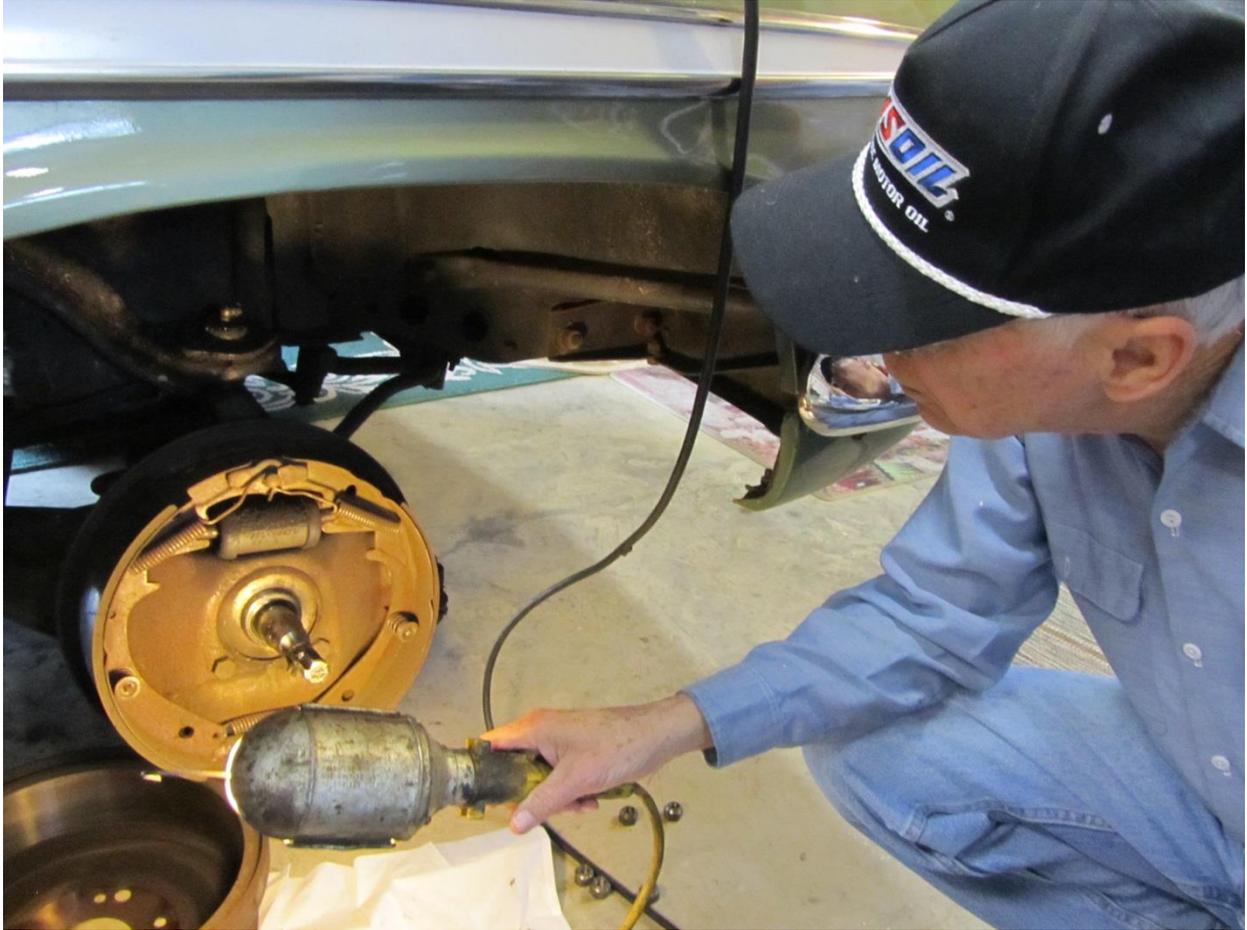
Bill O. got to work on removing the wheel and front brake drum with assistance from this author. The outer bearing race was removed and the hub containing the bearings. Bill Brundyge inspected spindle and it was deemed to be in fine shape.

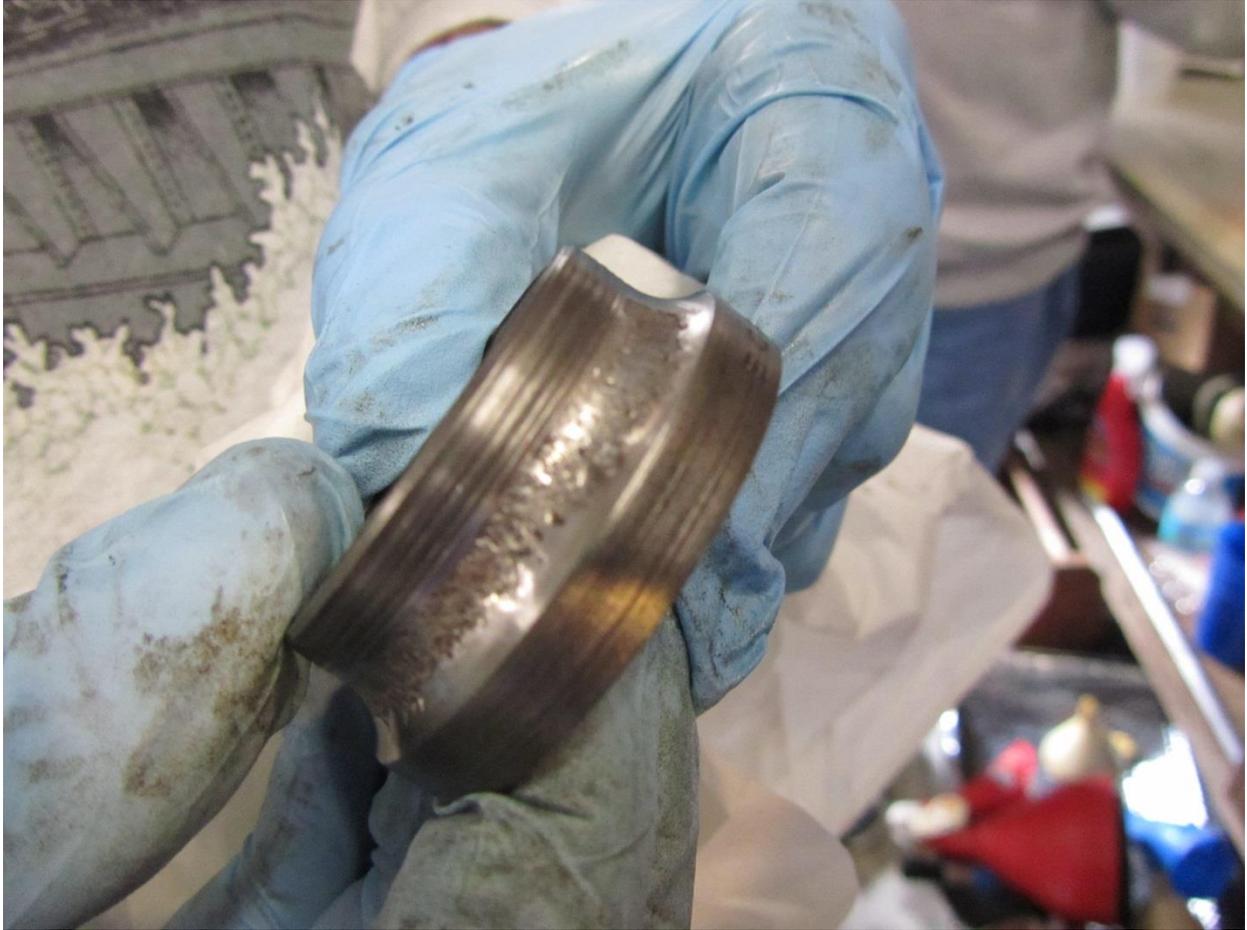
The inner bearing race felt rough to the finger test, but once it was cleaned of grease the reason for the noise was clear. The race had deep galling.

We were able to read a clear part number off the inner bearing race and Bill O. began making his parts needed list. A trip to NAPA would be required to order the correct parts. The crew celebrated the accurate diagnosis and verification of that diagnosis with coffee and donuts.

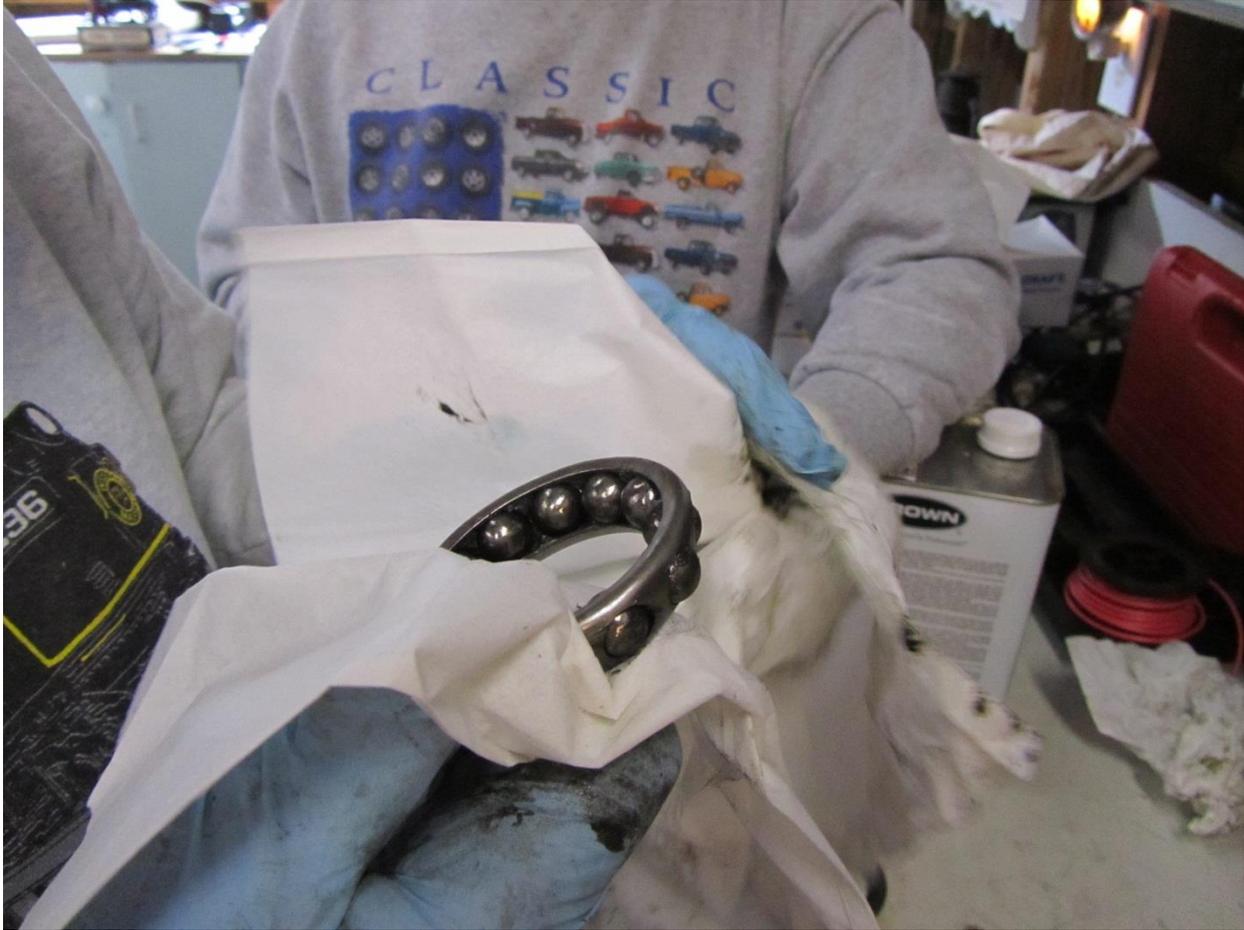
As the bearings were lifted out of the hub for inspection, the Model A owners began to get excited. The 1959 Chevy had been riding around on round ball bearings just like the Fords from the 1930s! No fancy taper roller thrust bearings needed here—if it was good enough for granddad, it's good enough for us. The outer bearings and races were in very good condition, the inner bearings had taken all the wear-and-tear.

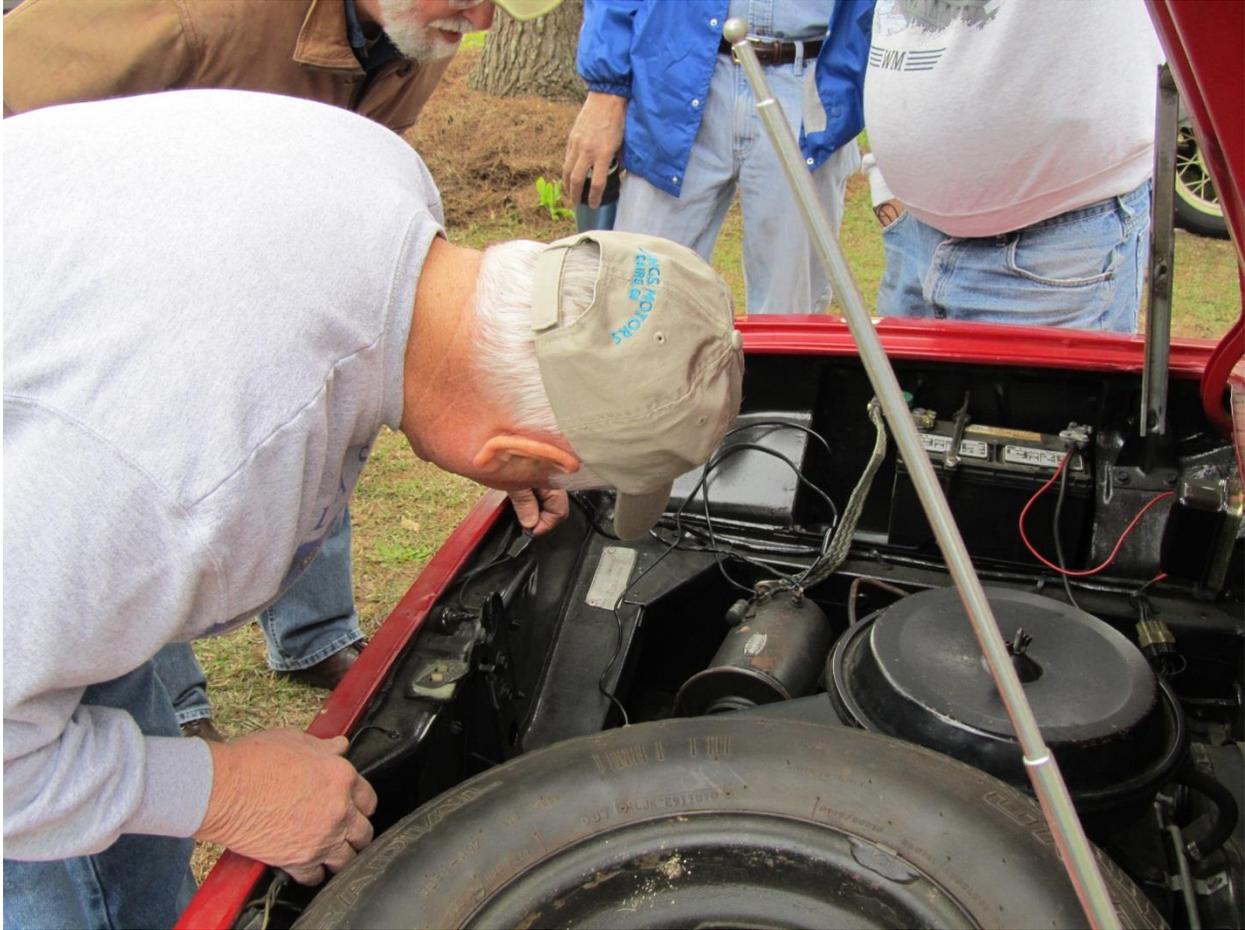
Bill O. next described the problem with his 1964 Corvair. The car would not start by cranking with the ignition key, but could be push started and would run once cranked. The club members familiar with English cars didn't understand why this was a problem.

A jumper wire, or 'hot wire' as known by the former juvenile delinquents in the group, was attached from the battery to the hot side of the coil. This allowed the Corvair to start and run just fine. Something was happening in the wiring, connectors or ignition switch to starve the ignition circuit of vital electrons.

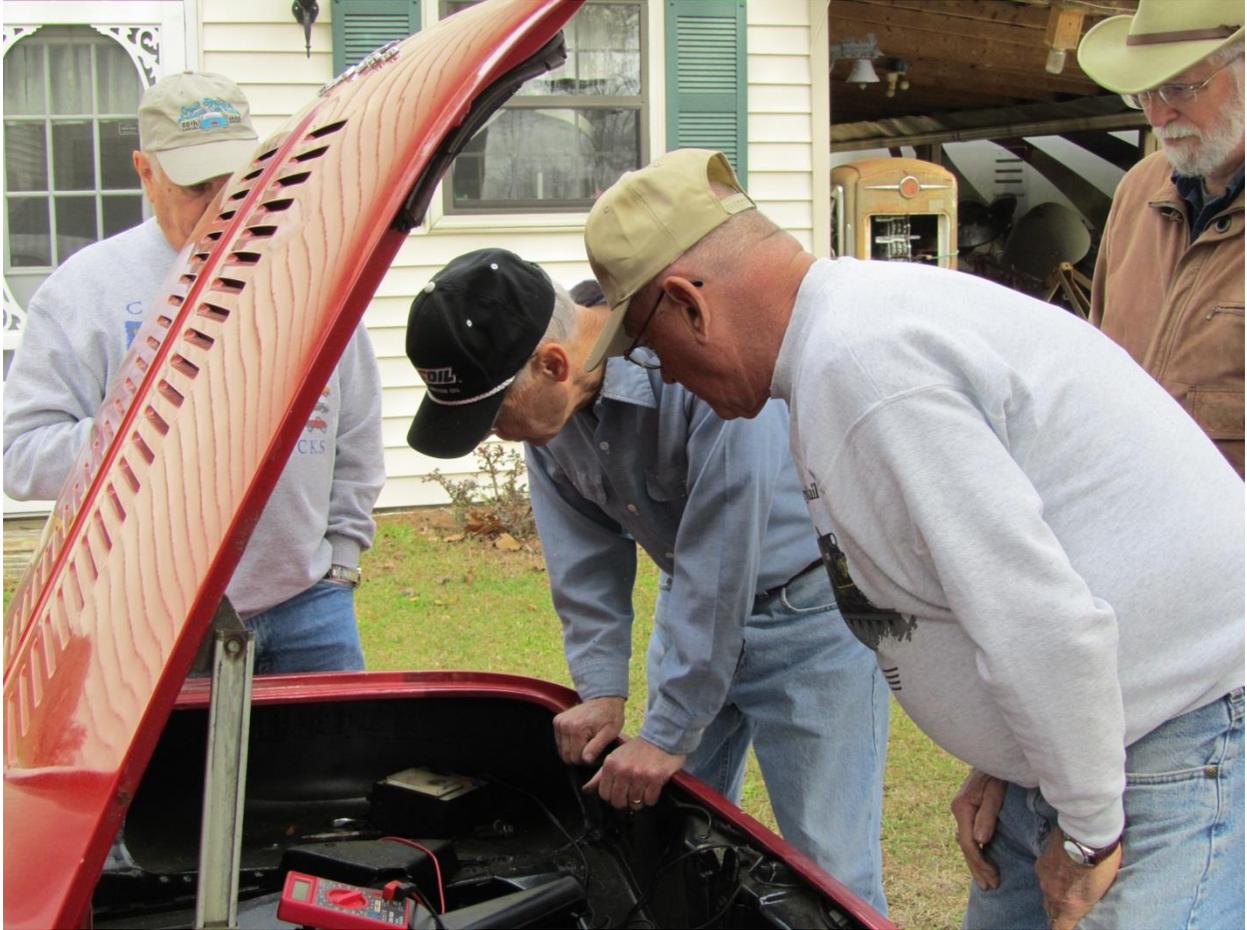
The next step was to bring out the test light and start probing. The light glowed, but not always brightly. A volt-ohm meter was fetched to get more scientific readings. The 12 volts at the battery was down to 4.62 volts by the time it reached the ignition coil. This Corvair has no ballast resistor, so that was eliminated as one of the usual suspects. Where were those missing electrons?

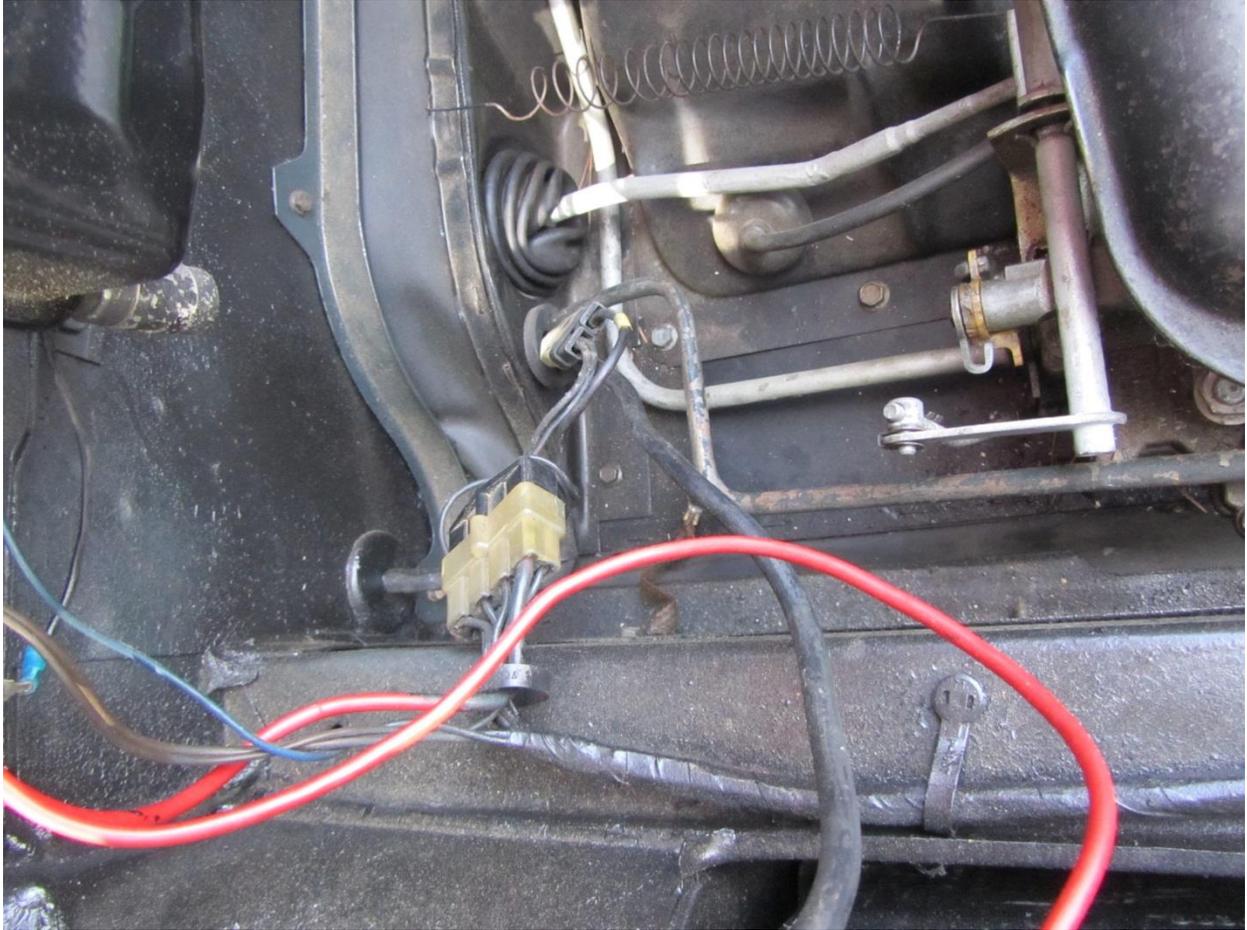
The group was getting restless and some members had to leave to fulfill other obligations. Bill B. and Ed Shuler would not give up. They traced every wire in the engine compartment, cleaned contacts and measured voltage drops. The black connector to the ignition switch was checked and it was fine. Someone pointed to the large clear connector (see in picture below) in the wiring harness and suggested disconnecting it and checking for corrosion. Once the connector was unplugged and re-seated, the Corvair would crank on its own and the voltage at the ignition coil rose to 10 volts (from a previous 4.62 volts).

The lesson learned is don't forget to check the connectors for both corrosion and proper contact when tracing an electrical circuit. Check for voltage drop across the connector in case it is a poor, but not completely broken connection. This can save a lot of time when chasing electrical problems. A corroded or poor connector can have a drastic effect on the current available in the circuit.

Bill O. promised to pick up some contact cleaner at NAPA and do a proper cleaning of the connector. We are confident this will result in a proper 12 volts making it to the coil and the Corvair should be back to consistent cranking.
