## TRAACA Tech Day: 1966 Ford Thunderbird Power Steering Pump Replacement By Craig Brown

August 26, 2017 Norm Madsen's Garage

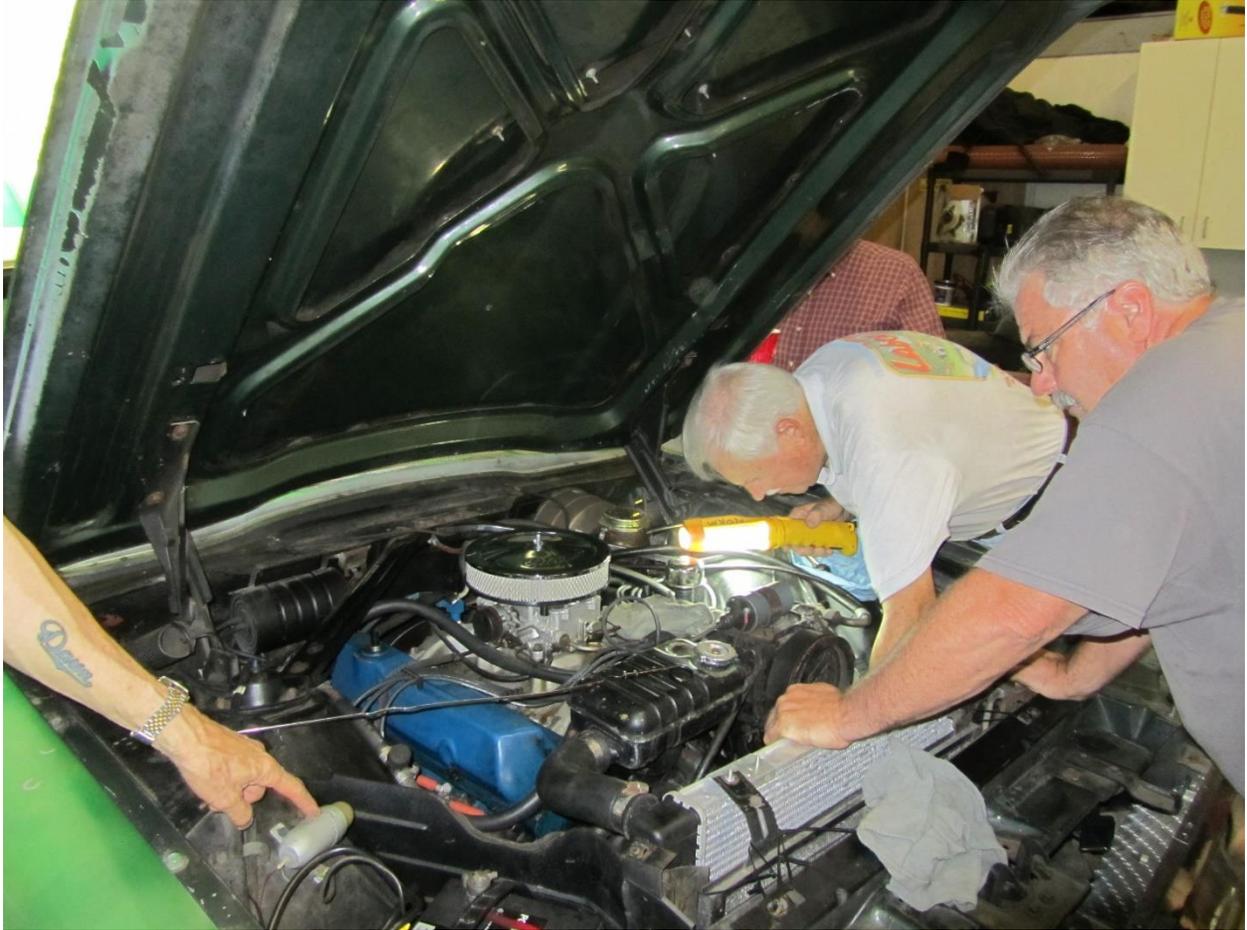
The Thunderbird has the advantage of the Ford 390 cubic inch monster torque engine, but also has the disadvantage of the fender well to fender well expanse of this big-block power plant. The power steering pump is on the left side up against the left fender well.

Paul and Jack determined the best way to extract the old pump and had it out in record time. Strategic placement of cardboard and a drain pan underneath the Thunderbird caught the Type F transmission fluid that had not already leaked out. This is important because as we all know transmission fluid, much like blood, always looks like more than it actually is when spread over a garage floor.

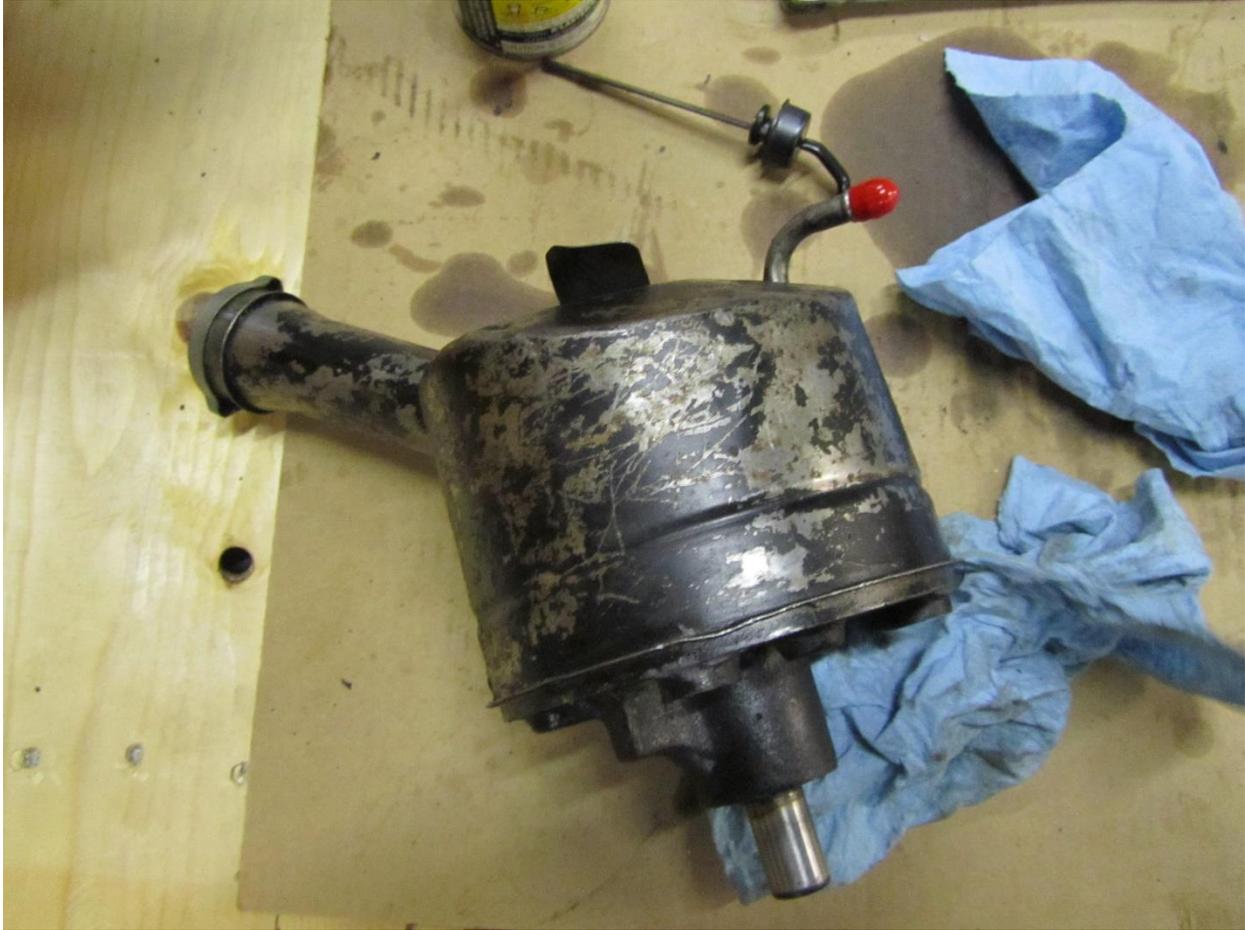
This is the old pump with the pressure hose and pulley removed. When checking the old part against the new, we carefully noted the location and thread pitch of the pressure side outlet and recognized the return line was 180-degrees opposite of the original. The return line pointing upward would actually make the installation easier. What we dismissed was the slight bevel on the back side of the old pump casing shown in the picture above. That missing bevel on the rebuilt pump was significant.

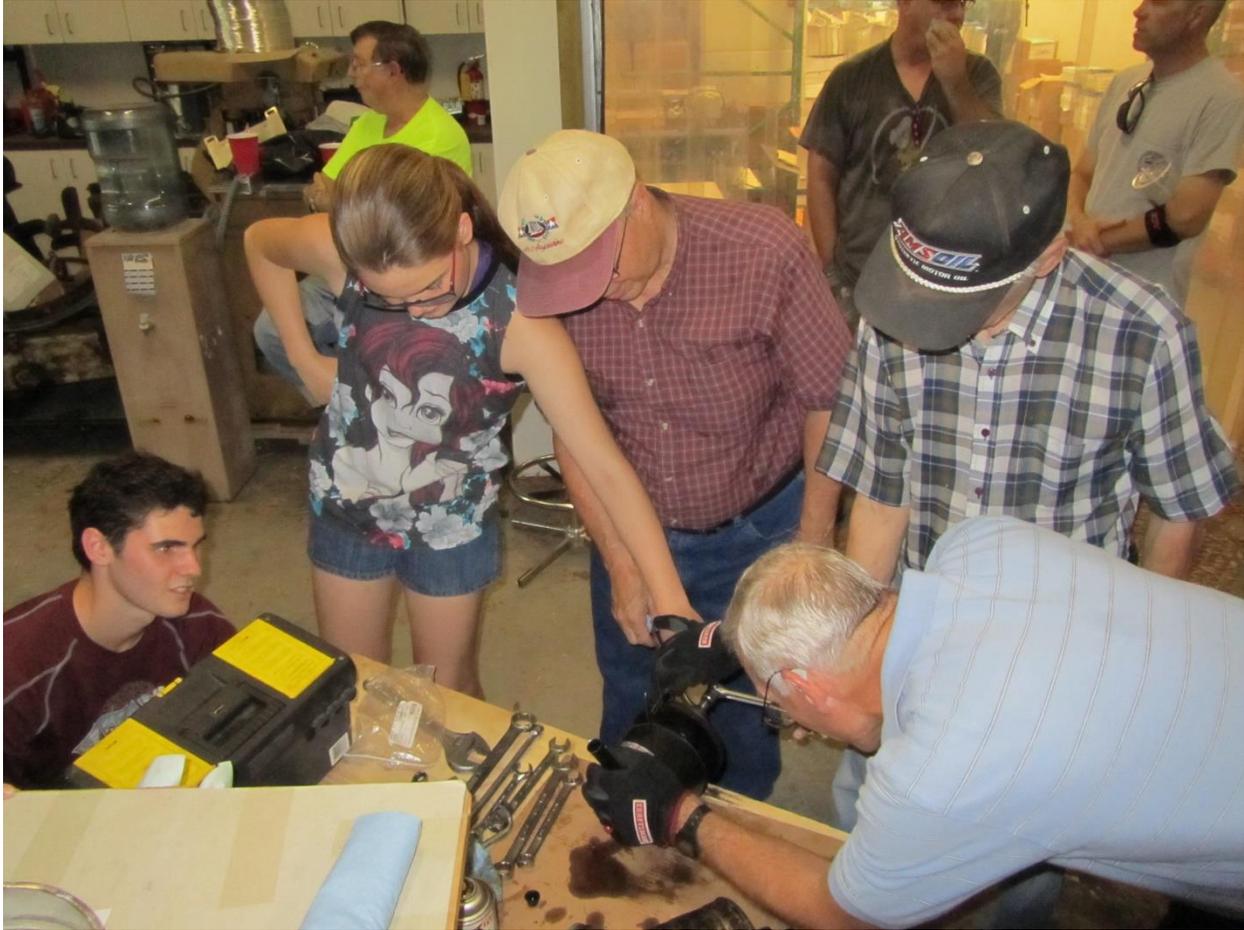
We had measured the clearance between the pulley and the pump casing with calipers to ensure the installation on the rebuilt pump would maintain proper drive belt alignment. In the heat of competition, the Thunderbird didn't need to throw off a belt! Seth, Ariana, Ken, Bill and Craig check the clearance and make the final adjustment above.

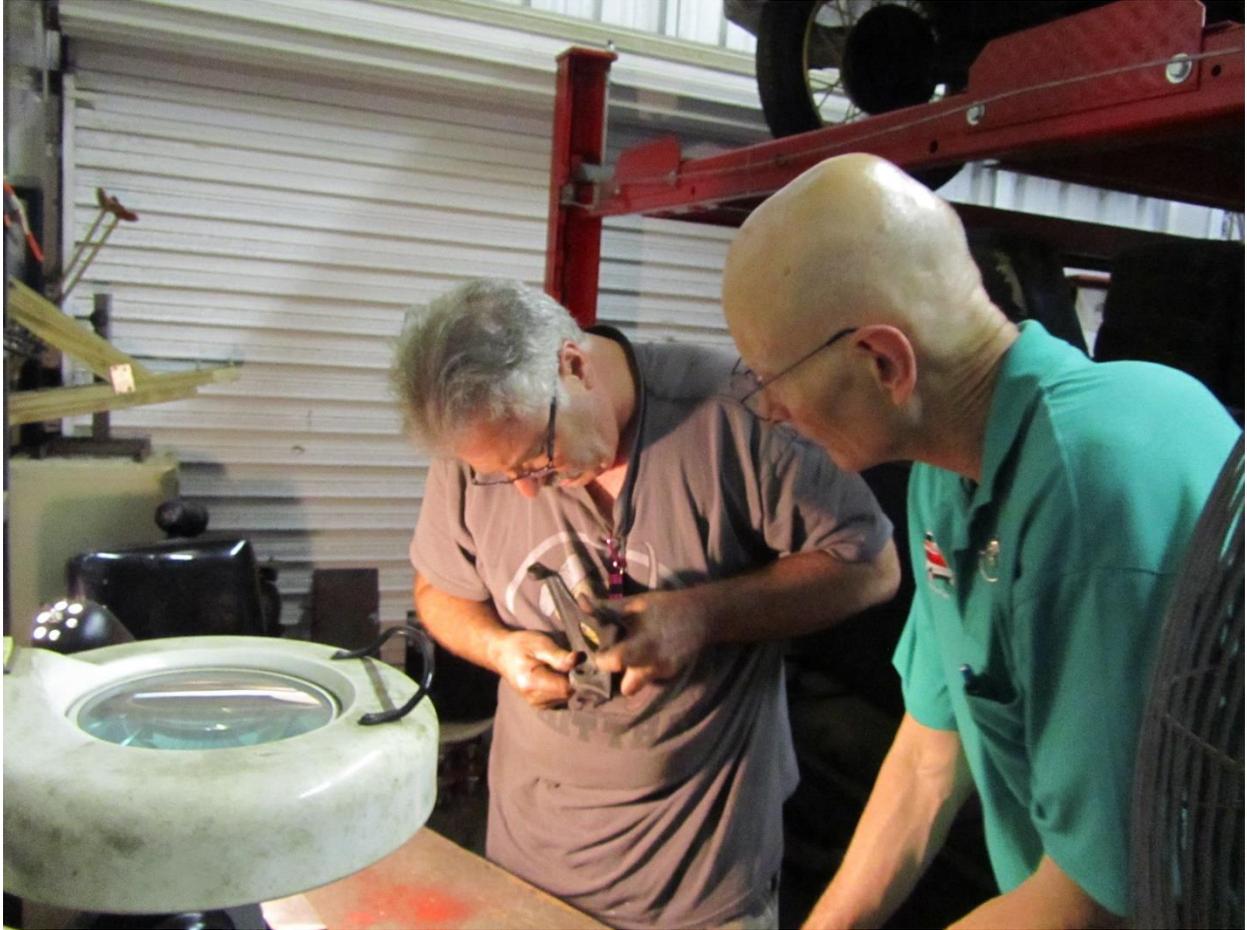
With the pressure hose loosely installed, it was time to put the rebuilt pump in the Thunderbird. Remember the slight bevel in old pump casing? The team quickly discovered the reason for the bevel while test fitting the pump. The bevel on the right side of the pump is to clear the mounting bracket and the bevel on the left is to clear the fender well. The new pump could be wedged in place, but it could not be moved enough to take up the slack in the drive belt.

The first alternative was to remove the pump mounting bracket and begin grinding to alleviate some of the clearance issue. Paul and Norm work on the bracket above.
