TRAACA Tech Day: Compression Test
By Craig Brown

July 13, 2013 at Bill O'Rourke's Garage

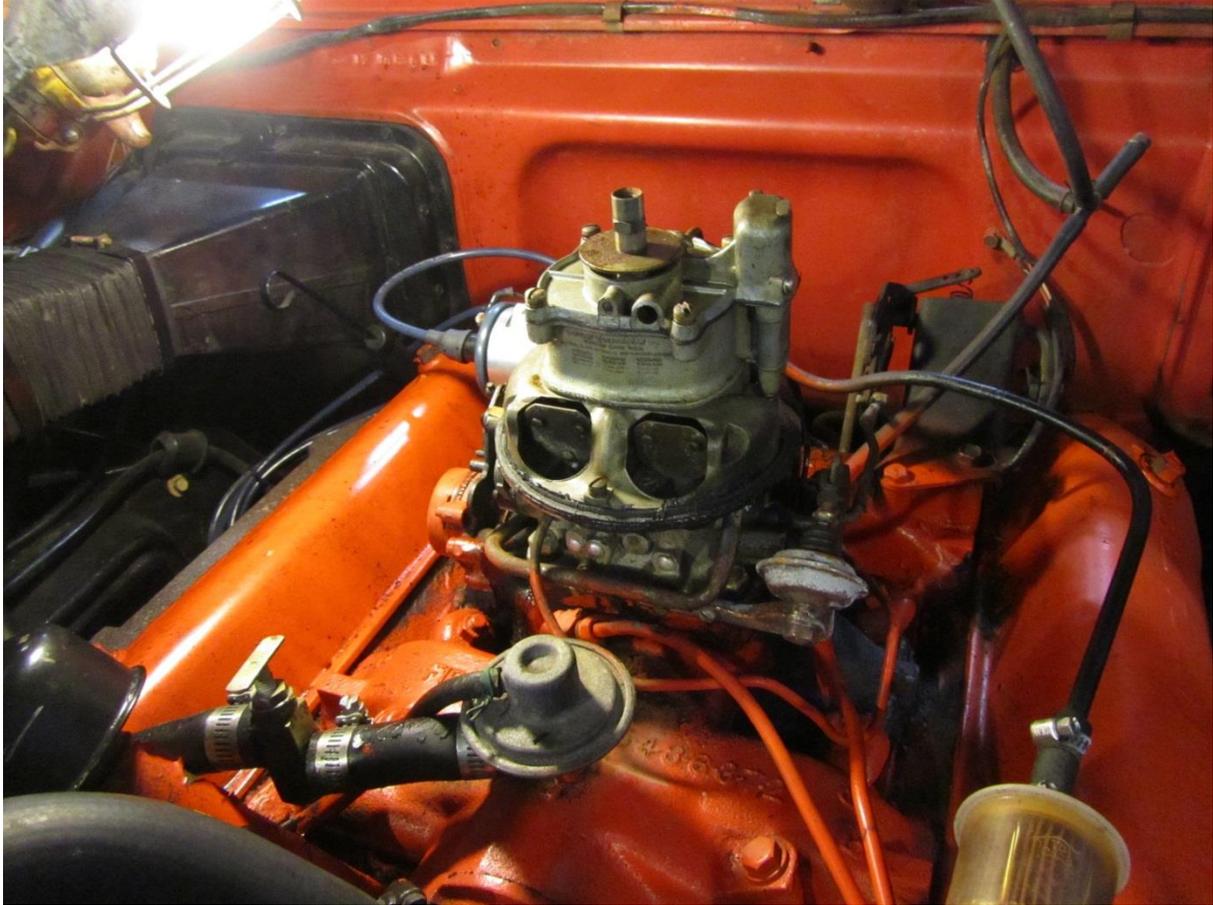
Soon the spark plugs were all removed and mounted in the carefully crafted holder (an old box with holes punched in it). The plugs had been in service for about two years and the insulator tips were all still bright white with little color variation between them. The consensus was this indicated a lean condition because the tips were not light tan. There was no sign of fouling or that one plug was consistently not firing.

Just to be on the safe side, Bill B. ran up to NAPA and bought eight new Autolite No. 46 spark plugs. After gapping the plugs to .032 inches and installing them, it was time to set the idle speed. With the idle set to 900 RPMs in 'Park' with no accessories, the speed would drop to 460 RPMs with the transmission in 'Drive' and the air conditioner running (specification is 450 RPMs). The engine seemed to idle smoother with these improvements from the outside, but Bill could still feel some shake from inside the car.
