## TRAACA Tech Day: 1966 Ford Thunderbird Power Steering Pump Replacement By Craig Brown

August 26, 2017 Norm Madsen's Garage

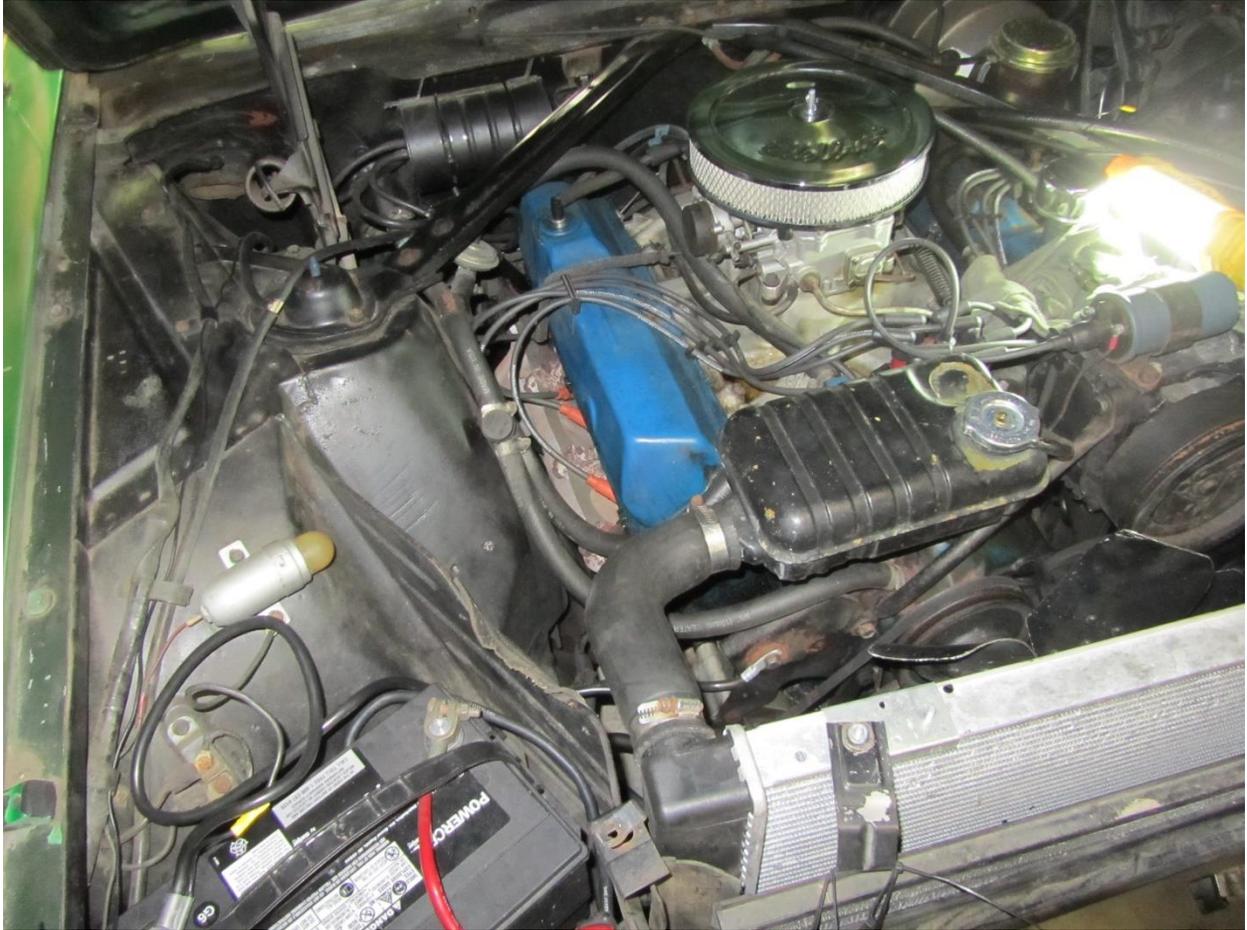
The Thunderbird has the advantage of the Ford 390 cubic inch monster torque engine, but also has the disadvantage of the fender well to fender well expanse of this big-block power plant. The power steering pump is on the left side up against the left fender well.
